# **Office of the Adjudicator – Broadcast Transmission Services**

**Report for the period 1 October 2018 – 31 December 2018**

## Audit of Arqiva site records undertaken in September 2018

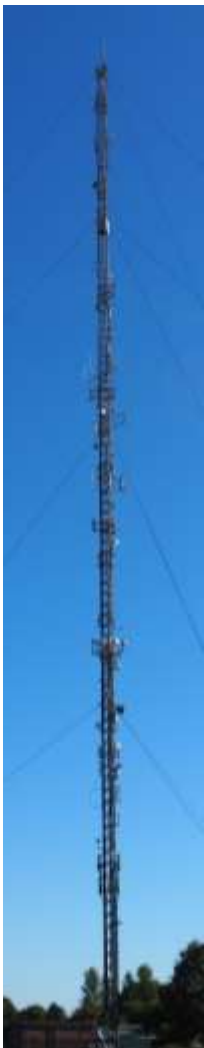
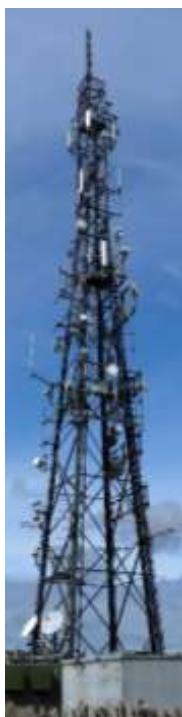
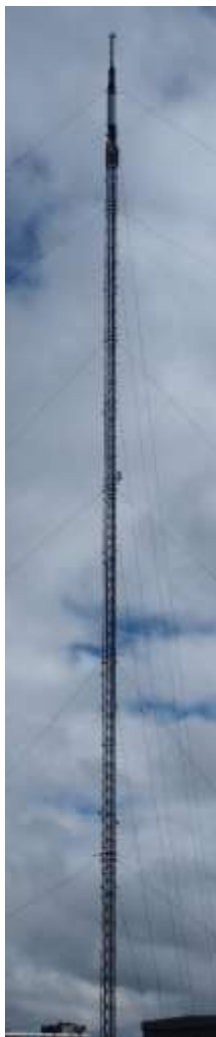
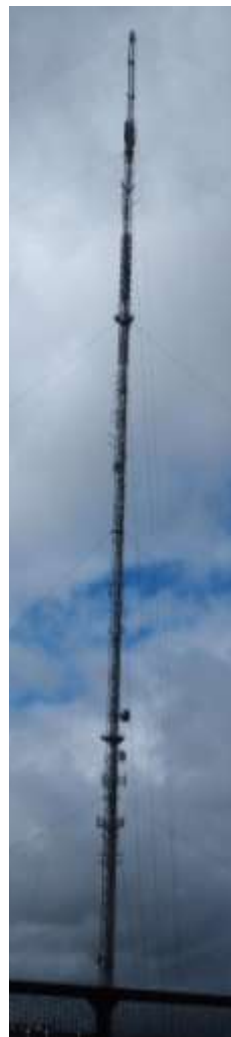
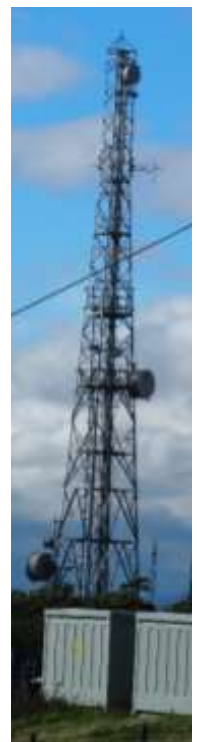
**Annex 1: Sample of site photographs**

**From the left; Membury, Winterborne Stickland, Bincombe Hill, Black Hill (TV mast), Black Hill (radio mast), Black Hill (tower)**
